Experimental investigation of the load-response and failure mode behaviour of modern dental implant materials

B. Crawford, C. Kopas (Perfit Inc.), G. Cowburn (Perfit Inc.), E. Boyle (Perfit Inc.), A.S. Milani*

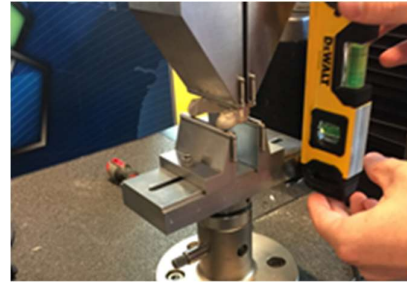
Figure 2: Mechanical testing set-up for the 4-point loading of dental implant samples, in an Instron 5969 load frame using an ASTM D790 fixture.

The loading condition of the dentures in this experimental analysis, was to focus on 4-point loading, which simulated the arch-loading condition of a denture when a user bites on a non-compliant material and often is the cause of implant mechanical failures. An ASTM D790 4-point bending fixture was used to simulate the load, shown in Figure 2. This set-up was used for all materials considered in this study, with the same displacement control ramp of 1 mm/min. There were seven different samples used, each composed of different materials. The samples were chosen to enable a comparison between the conventional material choices and the FRC alternatives. The samples of FRC, FRC Layered with additional composite finishing, PMMA, BIOHPP and Zirconia samples were milled using an Imes-icore 650i suite. FRC layered with composite was produced in a layered 3-stage milling process. The bar with PMMA and full PMMA denture were produced using standard production techniques.

The load-displacement history was collected for each sample, along with photographs of the fracture planes for post-test failure analyses.

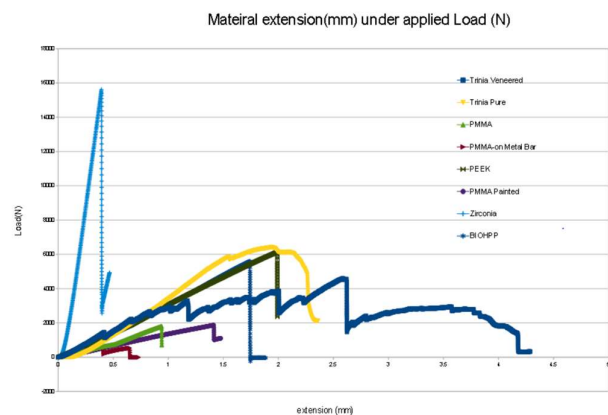
Figure 3: Load-displacement plot for Trinia veneered, Trinia pure, PMMA, PMMA on titanium bar, PEEK, PMMA painted, Zirconia and BIOHPP dentures.

Mechanical tests were performed on each sample and have been summarised in Figure 3, illustrating the load-displacement history of each material. It can be seen that each material type has different ultimate loads, stiffnesses and failure loads, the latter of which are progressive in some samples (e.g. FRC), while brittle and catastrophic in others (e.g. Zirconia). It should be noted that all samples were configured structures in this test, so the results shown are not only indicative of the properties of the materials used, but also the manufacturing process used for each, resulting in nuances such as crystalline plane orientations that can either hinder or help the rapid propagation of cracks.

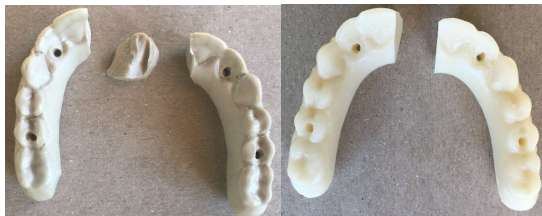
Figure 4: Failure modes of (left) PEEK and (right) PMMA. The PEEK experienced a significantly higher failure load than the PMMA, likely in part due to the manufacturing process used.

Investigations of sample failure modes has led to increasingly valuable conclusions about the relative strengths of each material, both from a purely structural point of view, as well as that from the view of patients. The latter is particularly important, in how patients may effectively communicate questions or concerns about dentures, with their practitioners and in turn, how practitioners may effectively understand structural issues and implement remedies. Figure 4 shows two distinct failures of similar polymer dentures.

In this example, the fracture plane of the PMMA sample was clean and indicated an amorphous structure, which resulted in a catastrophic failure (as with the Zirconia sample too). In contrast, the PEEK sample was highly crystalline and contributed towards a higher surface area fracture plane and higher failure strain energy. Figure 5 shows the non-catastrophic failure of the FRC sample, which exhibited

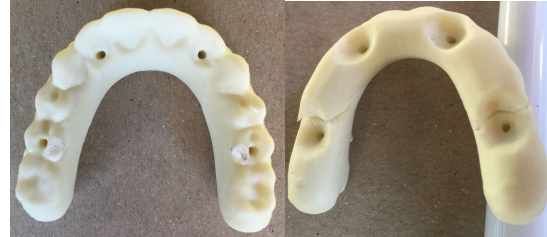
Figure 5: FRC sample shown in (left) top and (right) back-face orientations. The crack did not render the sample fully failed, with fibres bridged between the fracture planes for residual strength.

delamination on the back-face and local crushing failure on the load-supporting teeth. This illustrates the nature of the discontinuous FRC material and how patients may experience different thresholds of failure for different denture materials. Similarly, Figure 6 shows the titanium bar-reinforced PMMA denture, where the pure PMMA teeth fractured and sacrificially prevented damage of the substrate denture.

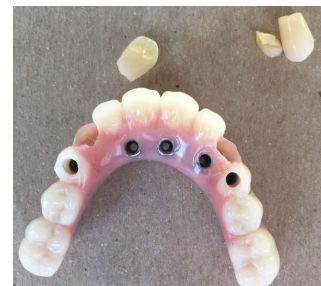
Figure 6: Titanium bar-reinforced PMMA denture, where the PMMA teeth failed and were removed before the main substrate was catastrophically damaged.
